Sept. 5, 1968
1003

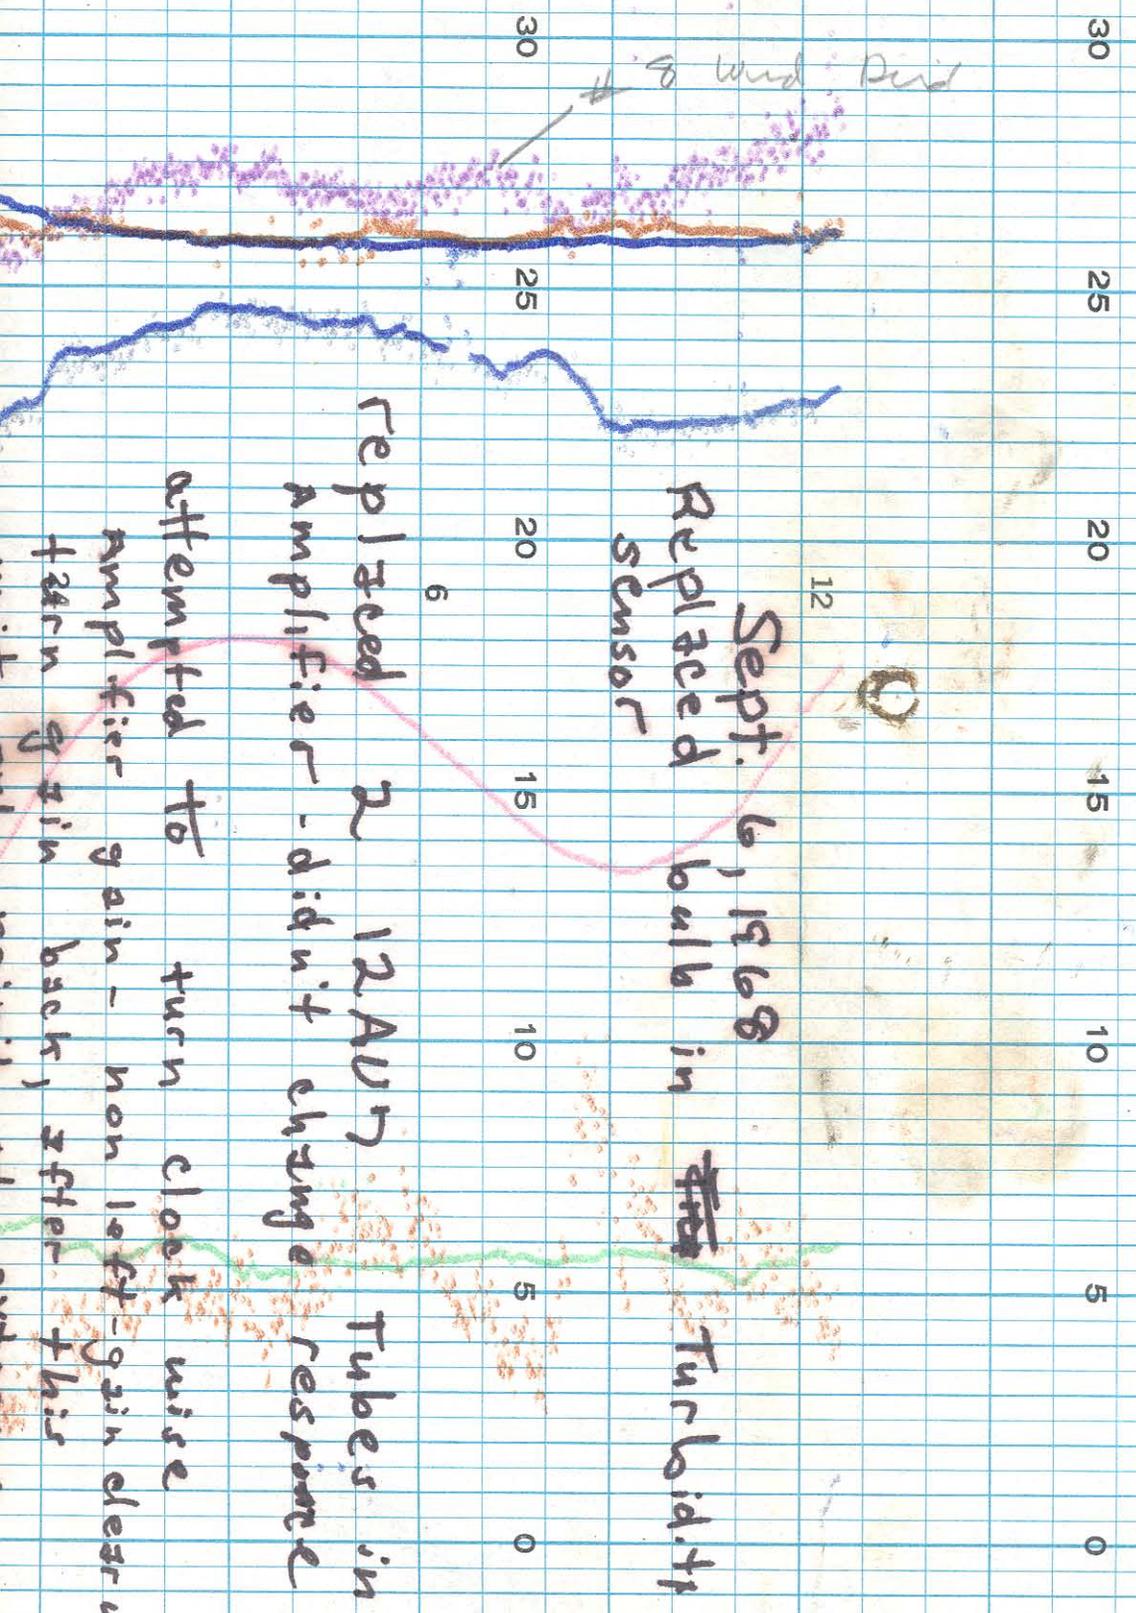
NO parameter printing correctly
NO response in span or zero set.

Sept. 6, 1968
 Replaced bulb in ~~the~~ Turbidity sensor

Replaced 2 12AV7 Tubes in amplifier - didn't change response

attempted to turn clock wise amplifier gain - non left gain clear up + turn gain back, after this

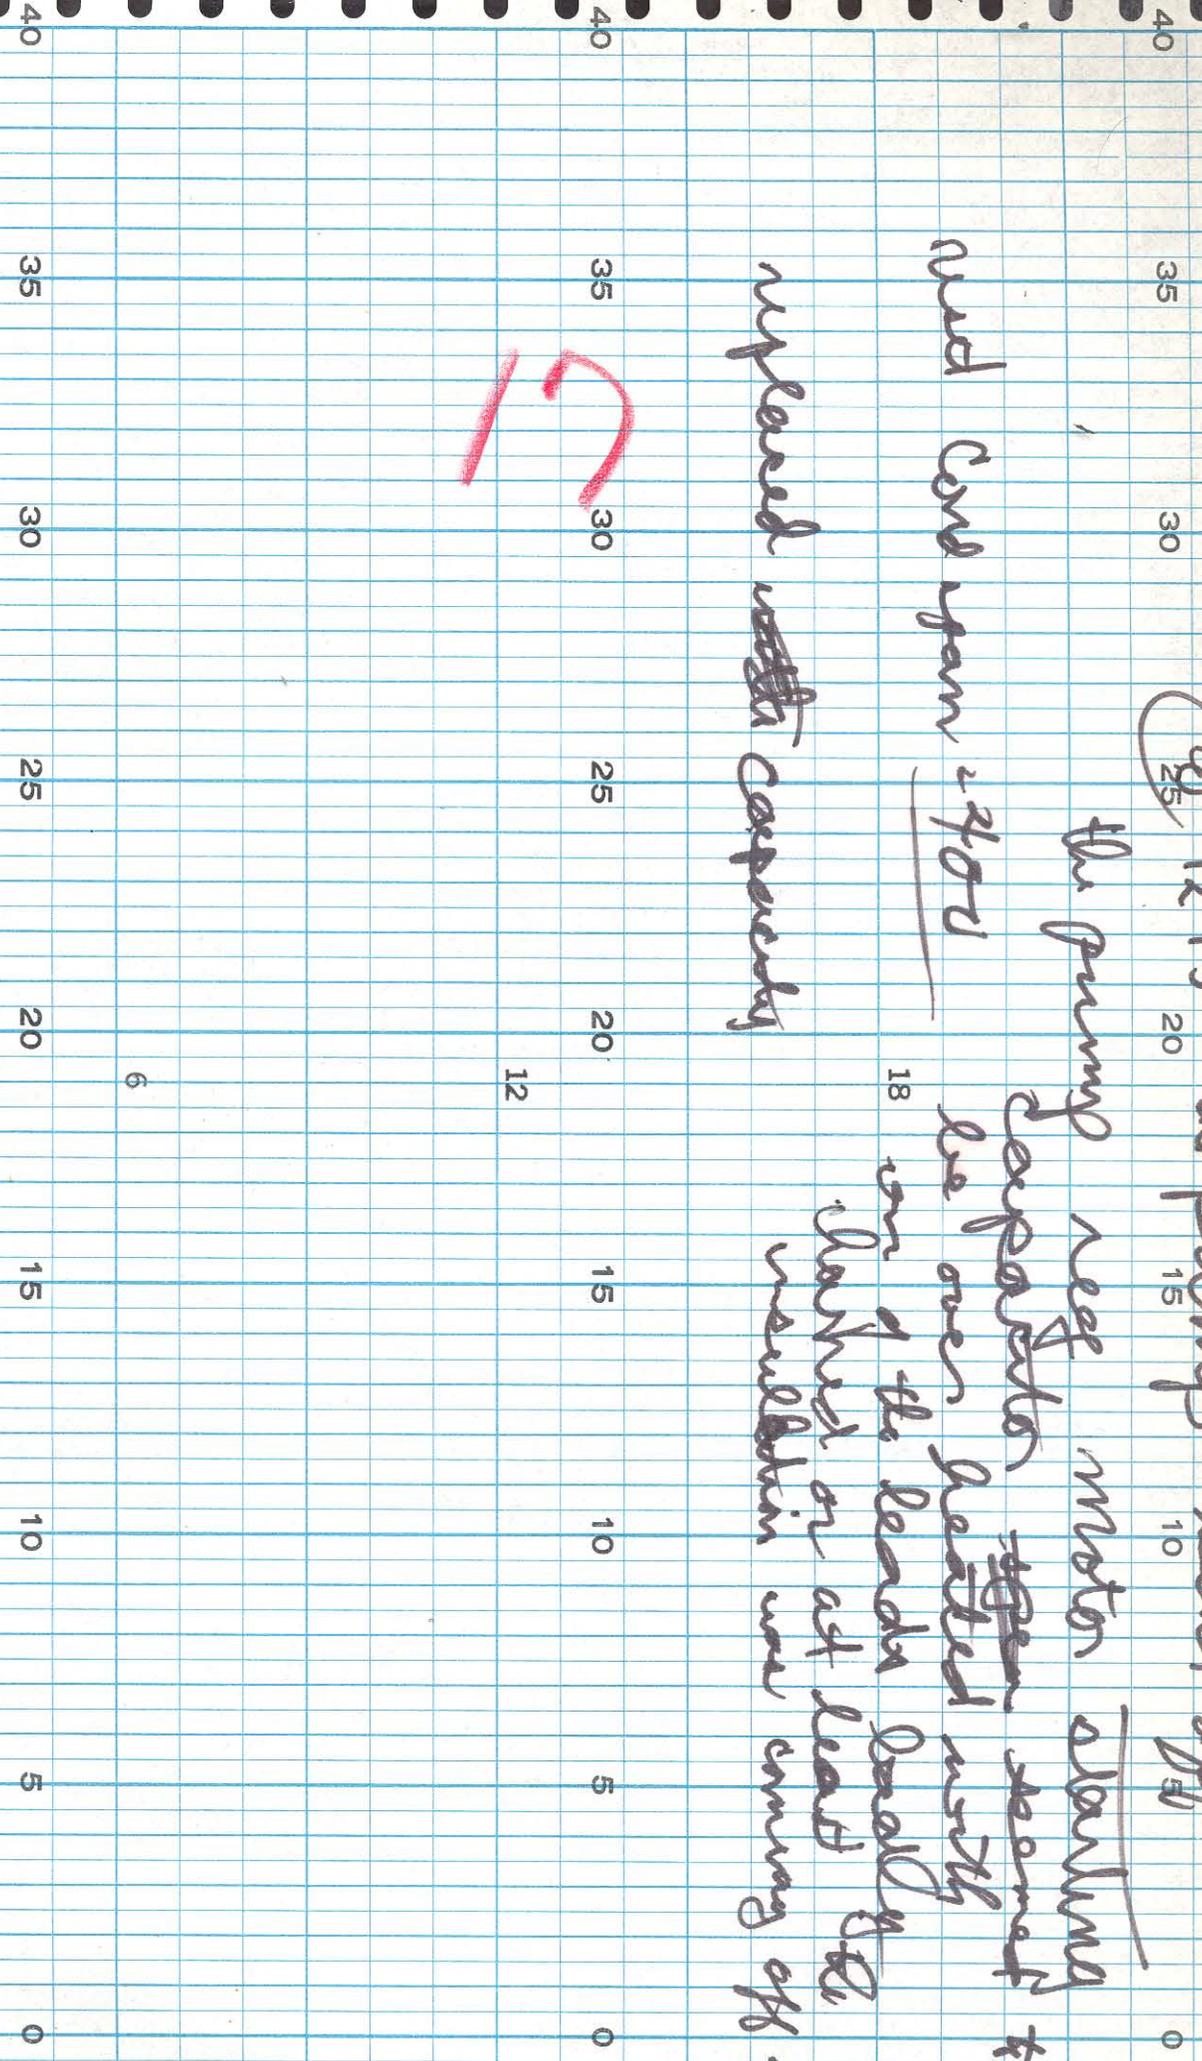
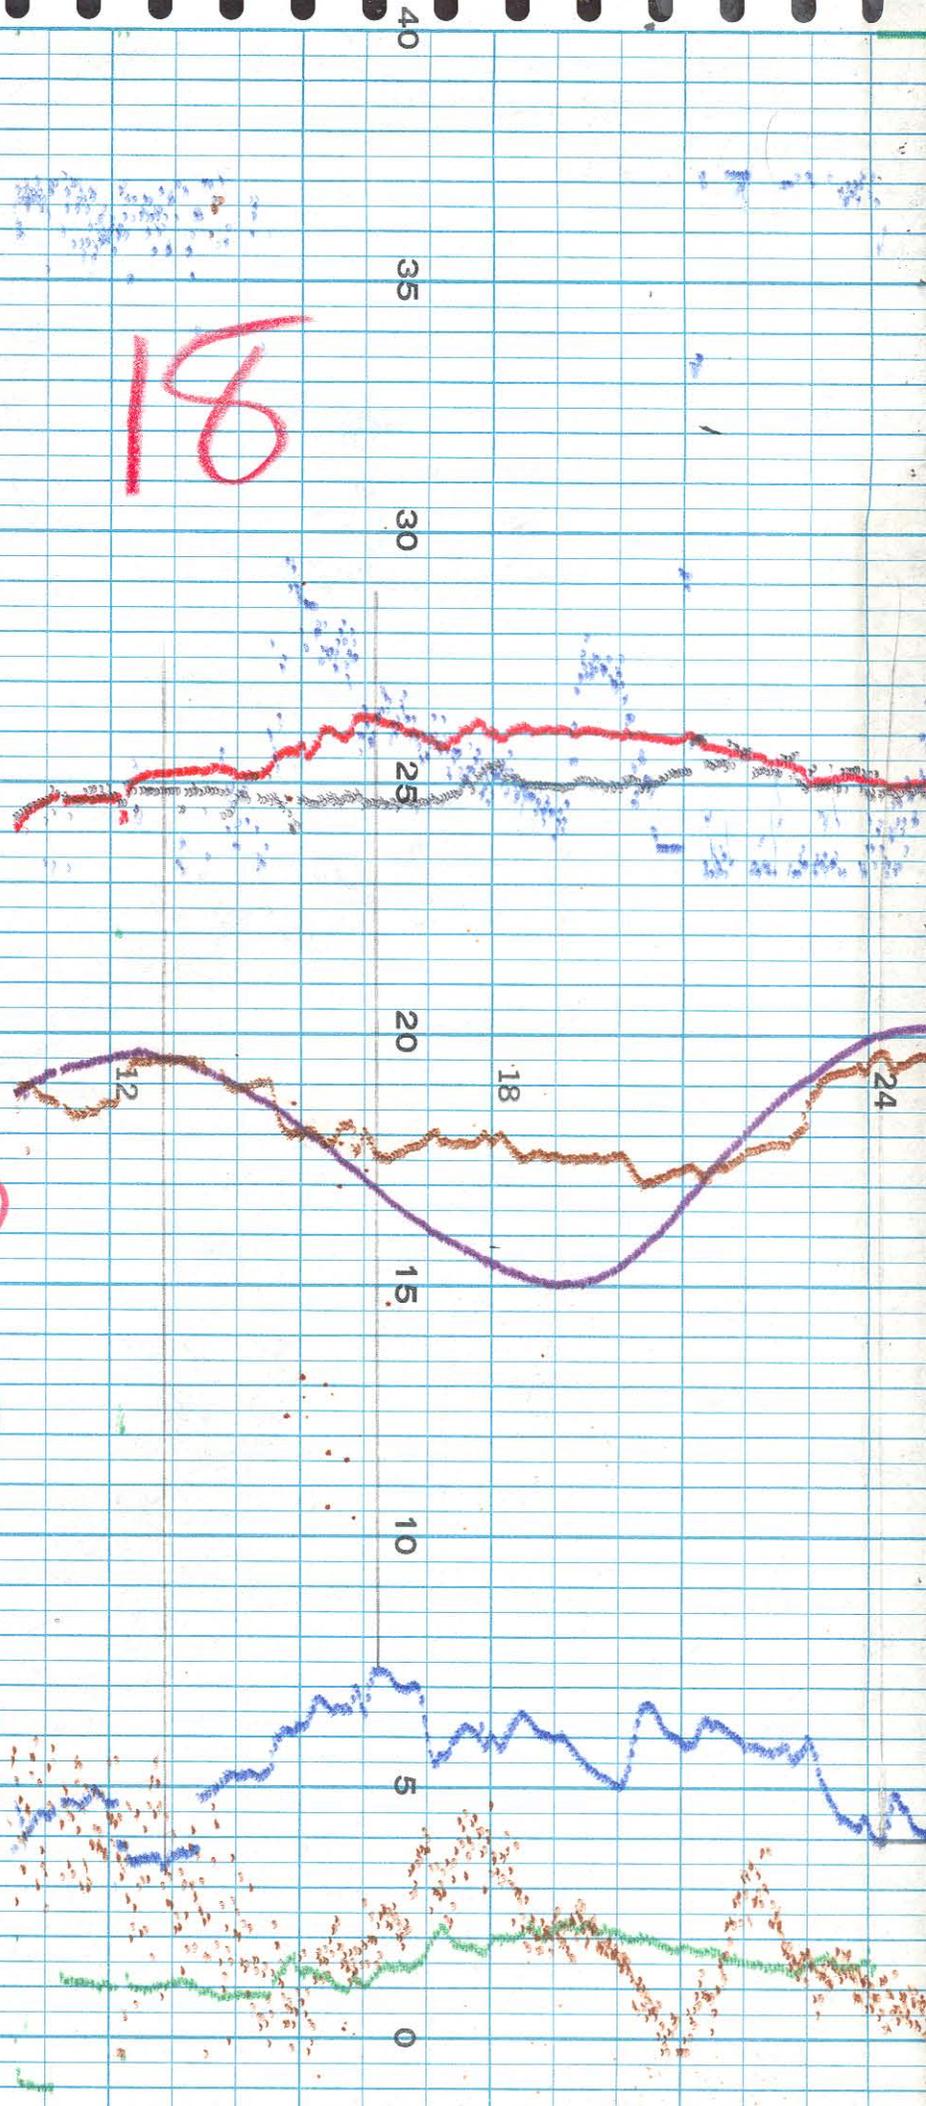
12:15 the pump went off

the pump reset motor shorting & capacitor ~~then~~ seems to be over heated mostly one of the leads possibly shorted or at least the neutral was coming off.

and come upon 240V

replaced ~~with~~ capacity
