Sept. 5, 1968
1003

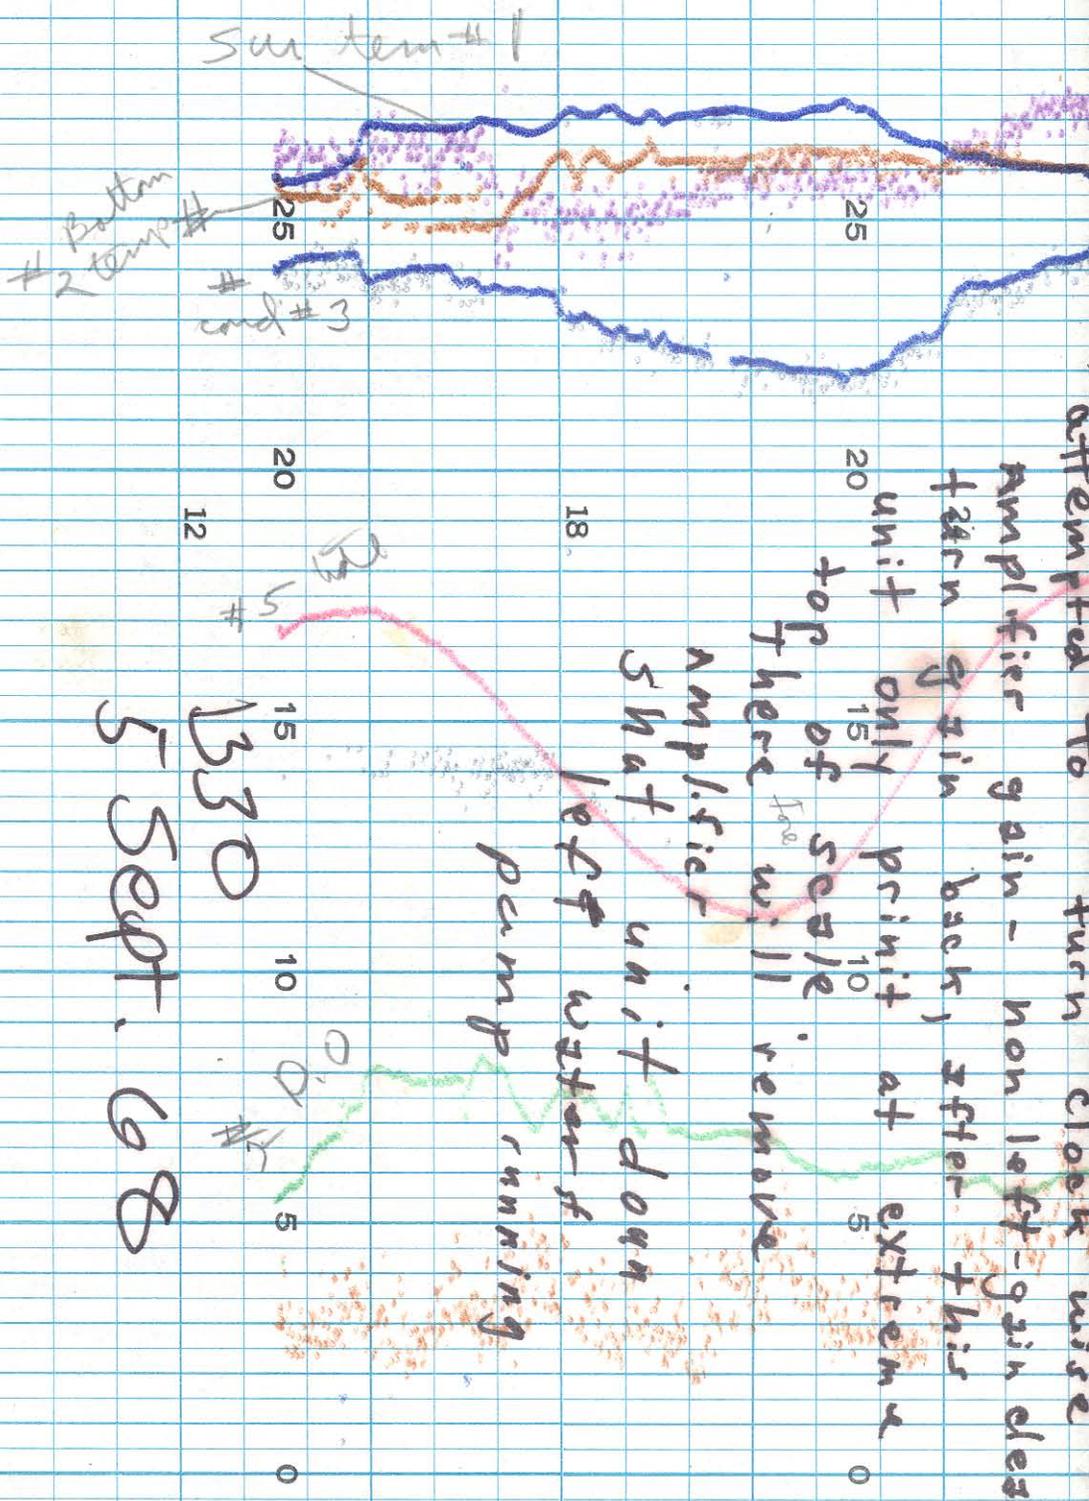
5 Sept. 68

NO parameter printing correctly
NO response in span or zero set.

Sept. 6, 1968
 Replaced bulb in ~~the~~ Turbidity sensor

Replaced 2 12AV7 Tubes in amplifier - didn't change response

attempted to turn clock wise amplifier gain - non left gain clear up + turn gain back, after this

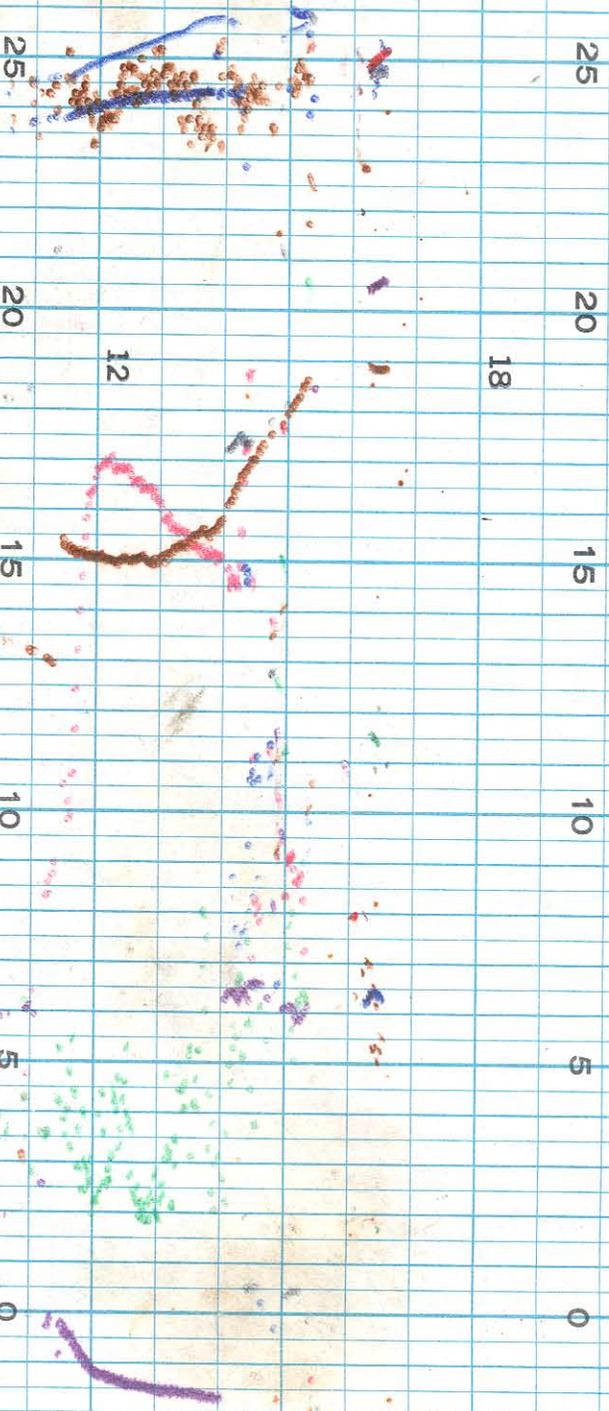
10 Sept. 68

all parameters readily sent upon
except wind direction and turbidity

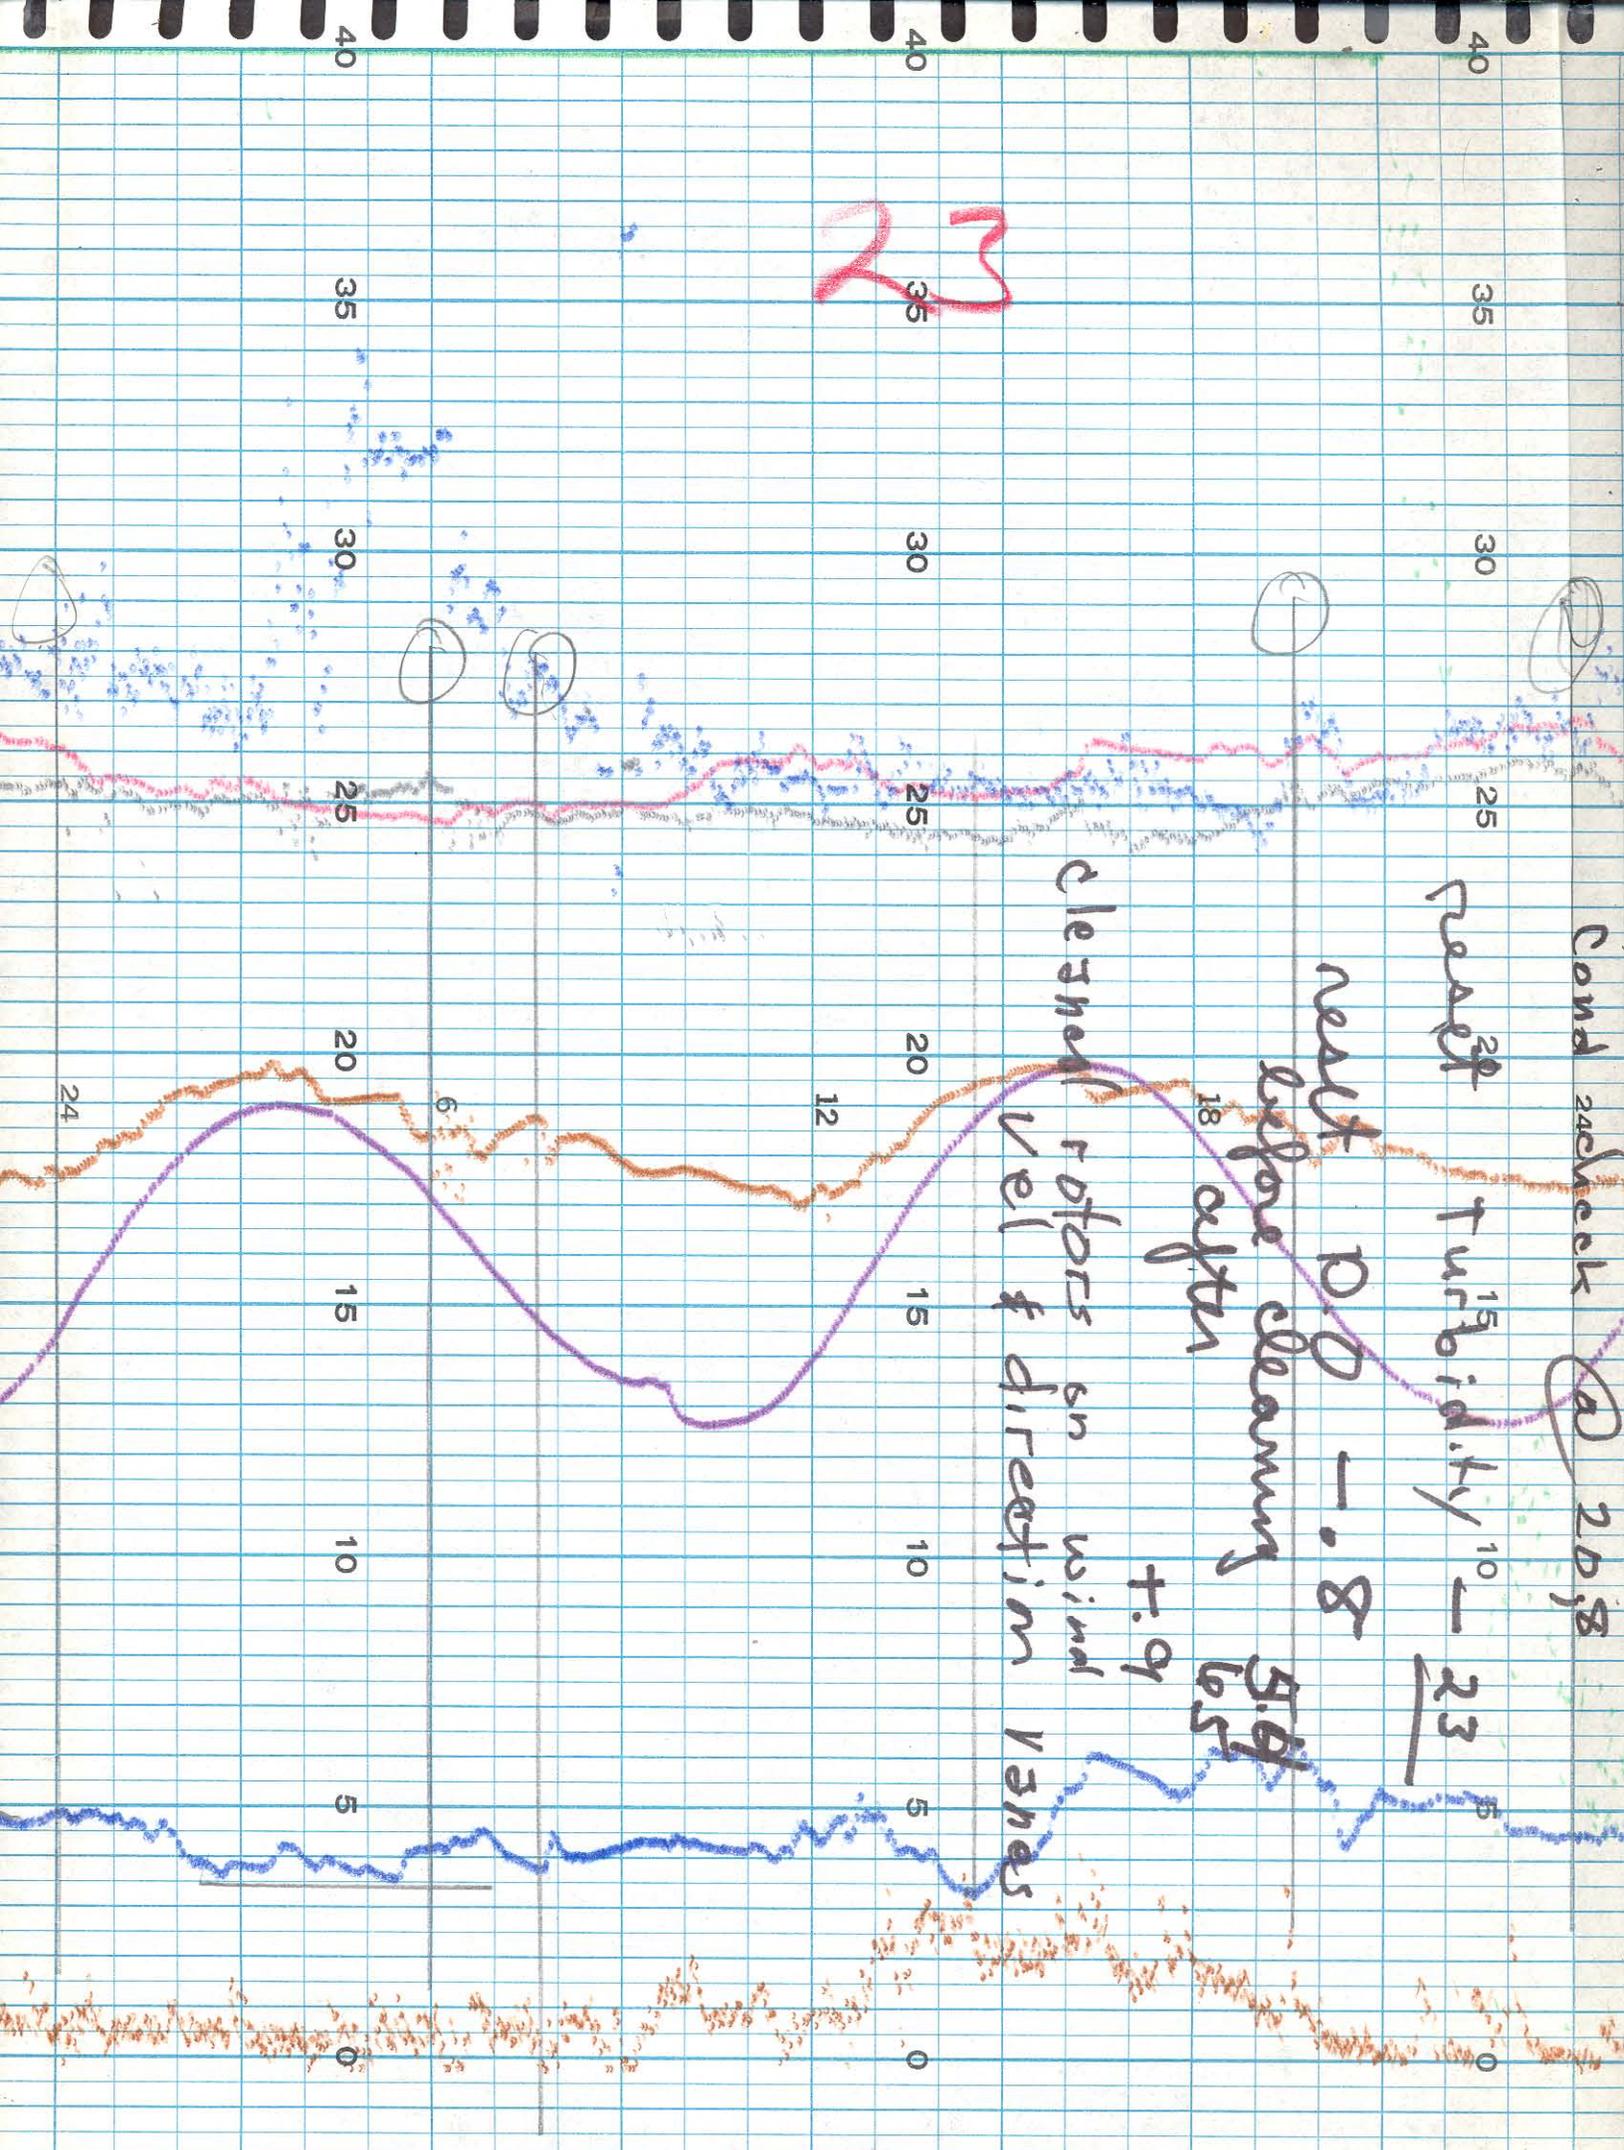
Cond 2nd check @ 20:38

rest²⁰ Turbidity¹⁰ - 23

rest D.D. - .8
 before cleaning 5.4
 after 6.5
 f: 9

cleanshaft rotor on wind vanes
 vel & direction
